Report No. UT-02.14

***PHASE II: SEISMIC
REHABILITATION OF
CONCRETE BRIDGES-
VERIFICATION USING IN-
SITU TESTS AT SOUTH
TEMPLE BRIDGE ON I-15***

Construction Report

**Utah Department of Transportation
Research Division**

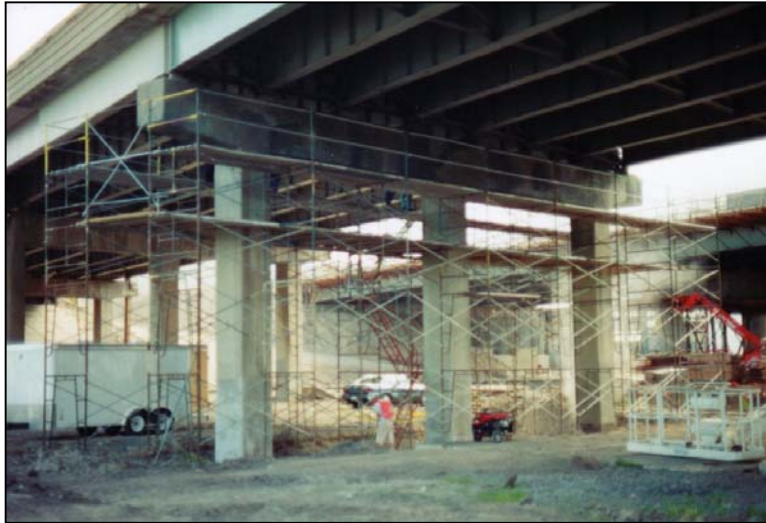
Figure 1. Bridge No. 58 Bent No. 6 Southbound I-15 at South Temple

Sika Corporation retrofitted the three square columns and cap beam on Bent No. 6. The columns were 3' x 3' x 24' (0.91m x 0.91m x 7.32m) from the footing and the cap beam cross-section was 36" x 48" (0.91m x 1.22m). The cap beam was 64.5 feet long (19.67m). This report starts with details of the initial condition of the bridge. The detailed design, materials used, cost of materials, tooling and procedure are included later in this report. Figure 1 shows Bent No. 6 and the scaffolding used in the retrofit operation.

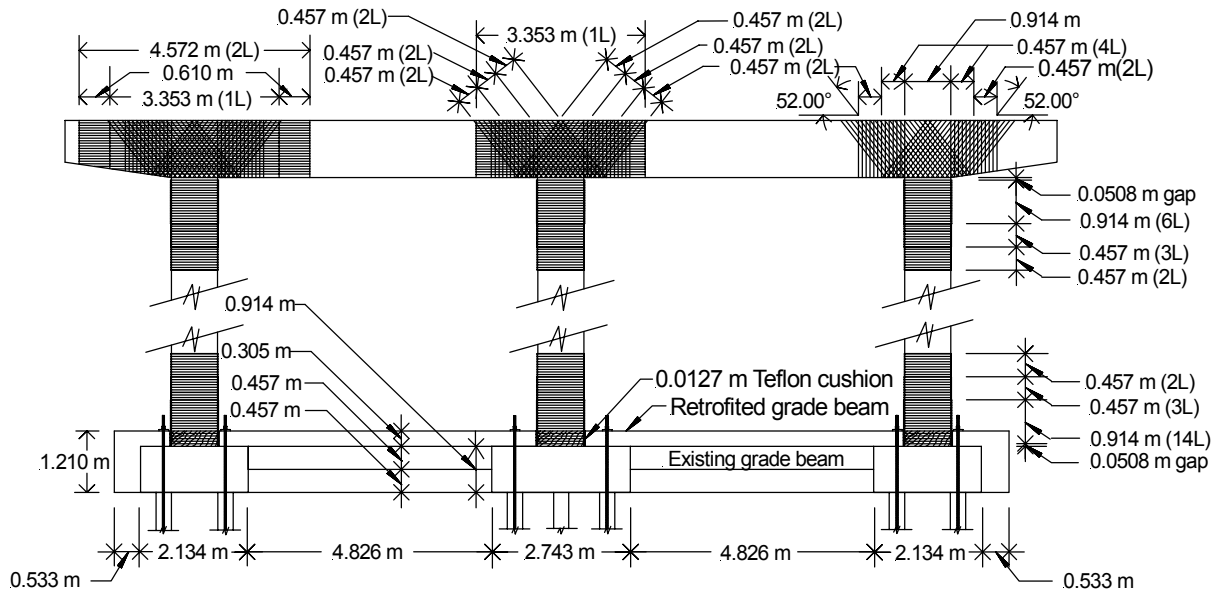
Figure 6. FRP Composite Design for Bent No. 6 – Part I

Figure 5 shows the overall dimensions of Bent No. 6 and Figures 6 and 7 the carbon fiber reinforced polymer (FRP) composite retrofit design for Bent No. 6. The design shows three separate wraps per column, i.e. bottom, top, and column-cap joint. The bottom and top sections are mainly composed of 0-degree wraps. The cap however consists of +52, -52 and 90 degree wraps.

The design is based on 18" (457mm) wide carbon fabric. Hence to achieve 3 foot (914mm) wide wraps (shown in Figure 6), we used two 18" (457mm) wide fabric wraps, placed side-by-side. All the fabric for cap beam used 18" (457mm) wide fabric. The vertical straps use 6" (152mm) wide fabric. The 0-degree wraps in the cap beam hold the 52-degree joint wraps in place through a clamping mechanism. The 6" (152mm) straps (shown in Figure 7) hold the joint together by relieving the vertical column bars of the high tensile forces, and by providing a positive connection between the cap beam joint and the column.

- 1) L = composite layers
- 2) All column composite layers are typical
- 3) East beam cap joint has 2 additional horizontal composite layers
- 4) Center beam cap joint has 1 additional horizontal composite layer

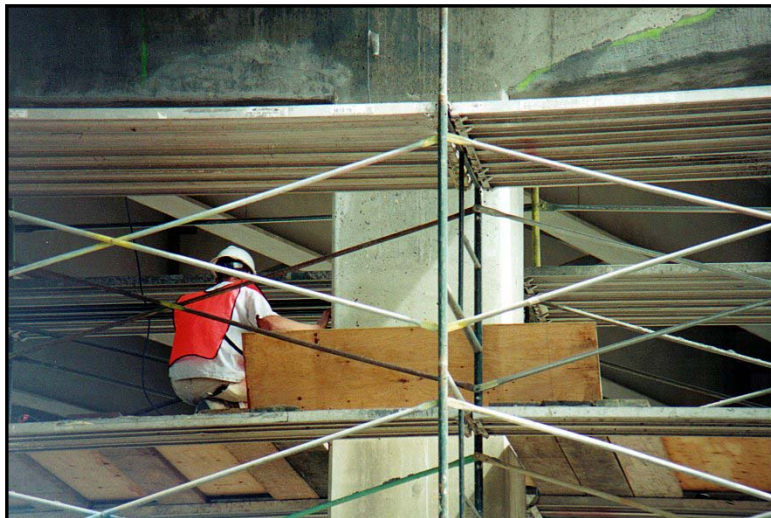
Figure 8. Cleaning Column

The first step for a successful retrofit job is to clean the concrete structure to ensure good adhesion between the adhesive and concrete. This was accomplished by using water jet blasting. Since the water jet was done one week before the columns were repaired, the surfaces had to be ground and brushed off to remove dust. The profiling material, Sikadur® 31 Hi-Mod, high strength structural adhesive, was used to patch large voids. All corners of the columns were rounded and smoothed using the grinders. After cleaning (as shown in Figure 8), patching and grinding, the columns were marked where the carbon fabric needed to be laid down. In the case of columns, the wrap started 2" (51mm) from the top of the footing and 2" (51mm) down from the column-cap joint. The application of Sikadur® 31 structural adhesive is demonstrated in Figure 9. The pattern layout procedure for both the columns and beam cap is shown in Figure 10.

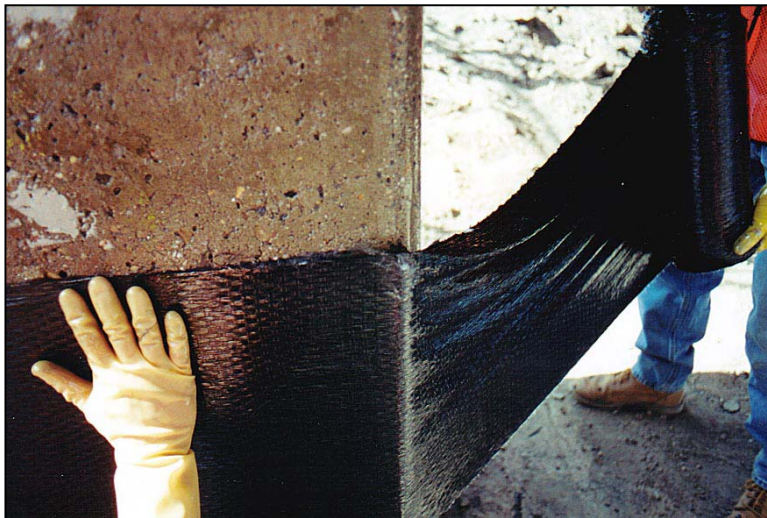
Figure 16. Applying Material in "Jelly Roll" Fashion

The "jelly roll" method, although saving time, may have been partially responsible for some void problems that occurred in a later phase of this project. These voids, when they were detected during application of the FRP composite, were worked out using various hand tools as shown in Figure 17.

- Jelly-roll installation process. This has been noted on other retrofit jobs.
- The resin, Sikadur® Hex 300, has a long gel and cure time. This could cause the fabric to "sag" under its own weight and cause layers to separate.

- Use of the fabric saturator is essential.
- Use of cementitious or epoxy leveling mortar on concrete before wrapping.
- Sandblast surfaces to receive FRP composite wrap.
- Use of Sikadur® Hex 306 epoxy.
- Apply fewer wraps at a time.
- Shading FRP composite from direct sunlight during cure.
- Covering FRP composite with a cementitious or acrylic coating to protect it from ultraviolet light damage for long-term performance.

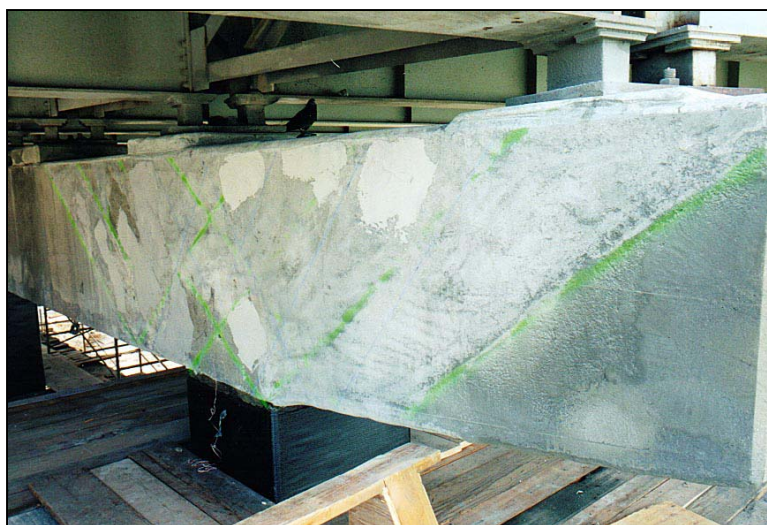
Figure 22. Profiling Material Applied to Fill Uneven Spots

All loose concrete material was removed and shotcrete was applied to the surface prior to the following procedure. The first step for a successful cap beam retrofit job is to clean the concrete structure to ensure good adhesion between the adhesive and concrete. This was accomplished by grinding the entire surface of the shotcrete that would receive the FRP composite material. The profiling material, Sikadur® 31 Hi-Mod, high strength, structural adhesive was used to patch large voids and fill uneven spots, as shown in Figure 22. Sikadur® 31 Hi-Mod, high strength, structural adhesive was also used as the prime (coat between the concrete and the first layer of carbon material) layer on the cap beam, as shown in Figures 23 and 24. All corners on the cap beam were rounded and smoothed using grinders. After cleaning, patching, and grinding, the cap beam was marked to indicate the placement of the carbon fabric.
